# PEDESTRIAN CROSSING STUDY OF BALBOA PENINSULA

August 2017

**ALBERT  
GROVER &  
ASSOCIATES**

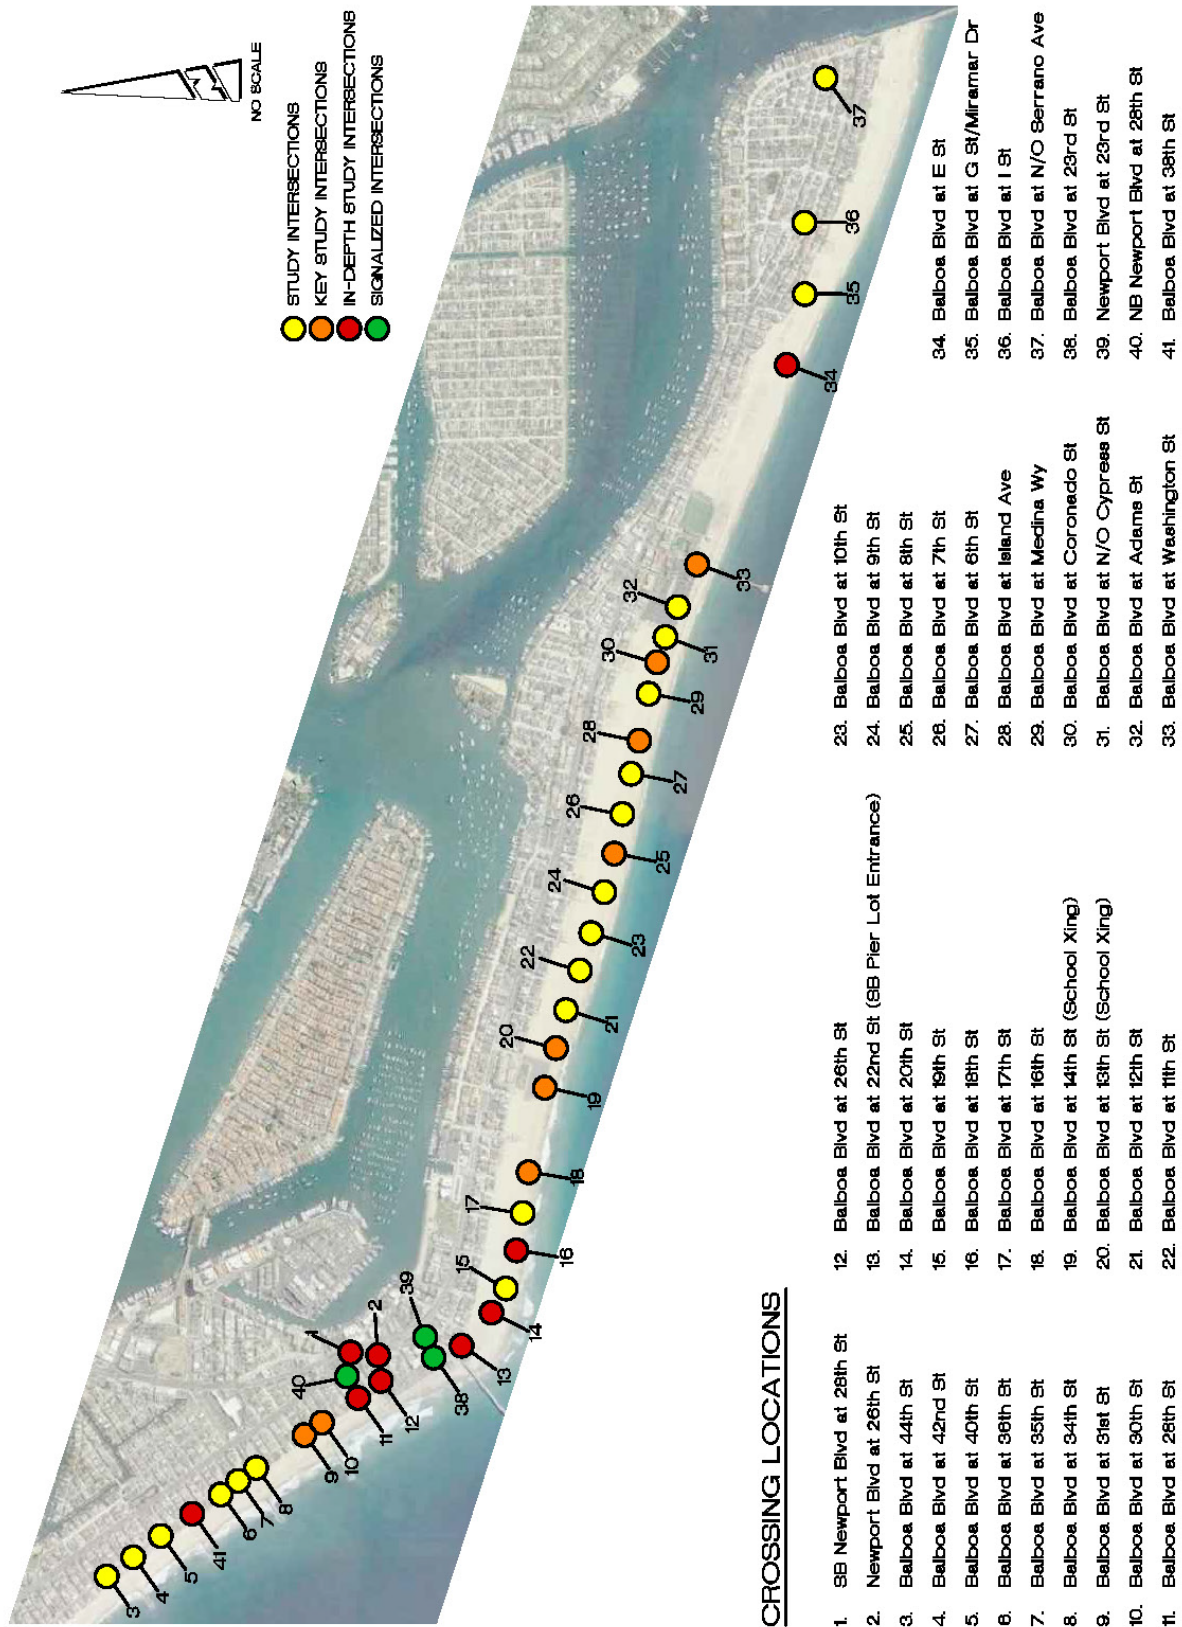
Figure 2: Study Area

The project study area is essentially comprised of both Newport Boulevard and Balboa Boulevard as they traverse the Balboa Peninsula. The study area is depicted in **Figure 2 – Study Area** on the following page. Vehicle circulation in the study area is controlled by traffic signals, stop signs, and pairings of one-way streets. Parking on the Balboa Peninsula is provided by a combination of on-street parking (both free and metered depending on the location) and paid parking lots operated by both public and private entities. Considering the high parking demand and close proximity of housing and businesses to the beach areas, the Balboa Peninsula also experiences high pedestrian activities, especially during weekends, holidays and summer months. To accommodate this brisk pedestrian activity, there are a total of forty-nine marked crosswalks on the entire peninsula at a combination of controlled and uncontrolled intersections between the two streets of Newport Boulevard and Balboa Boulevard.

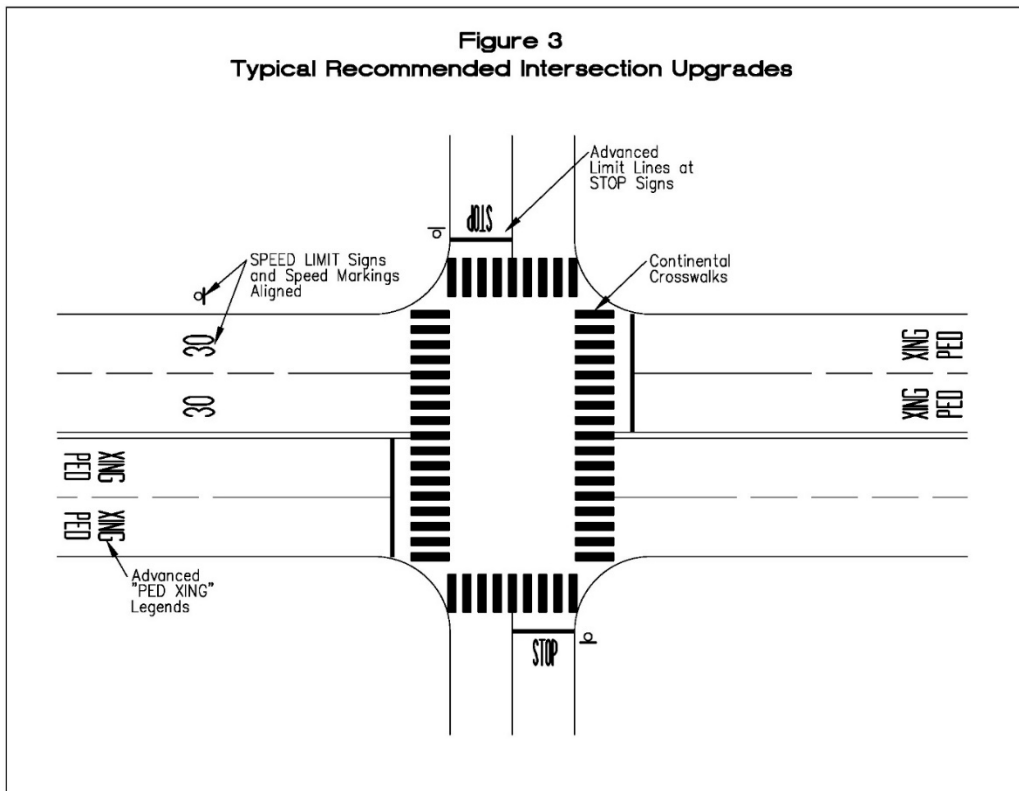
**Figure 3**  
Typical Recommended Intersection Upgrades

A re-striping of the existing crosswalks using continental type striping will increase the visibility of the crossing locations. Studies have shown that this type of marking increases motorist yielding and decreases the number of vehicle/pedestrian collisions (**Figure 3** on page 15).

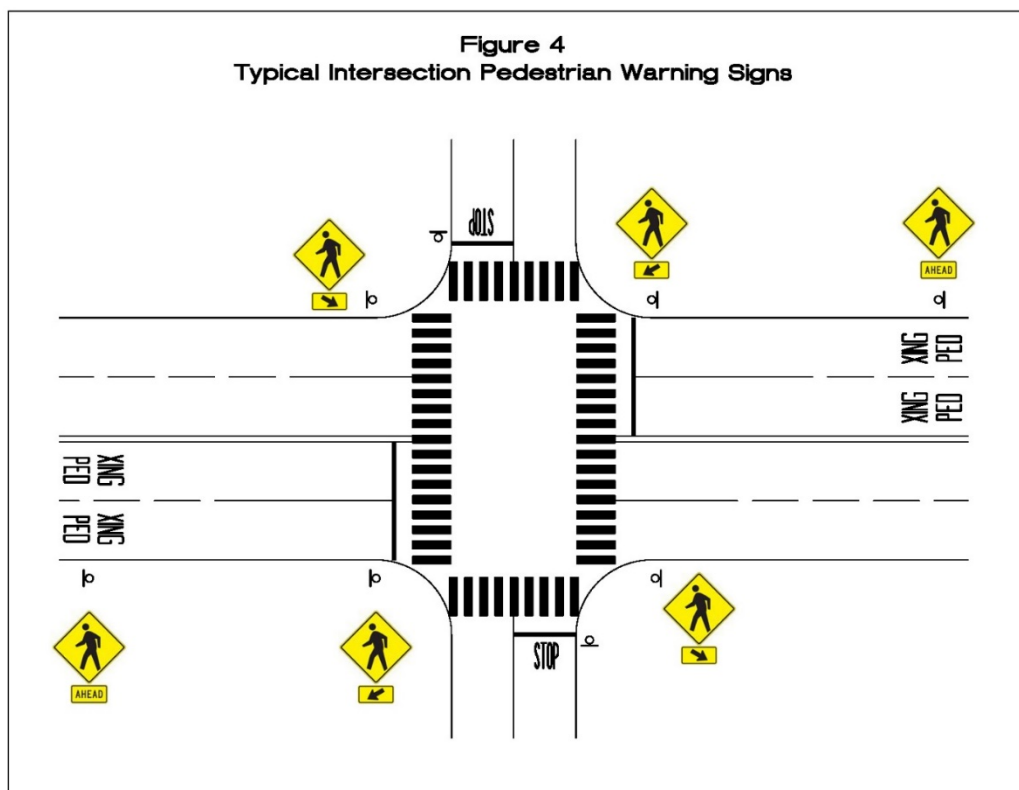
**Figure 4**  
Typical Intersection Pedestrian Warning Signs

Advance caution signage alerts the motorist to the upcoming crosswalk. When used with other pedestrian solutions, such as upgraded crosswalk striping, awareness of pedestrians is enhanced (**Figure 4** on page 15).

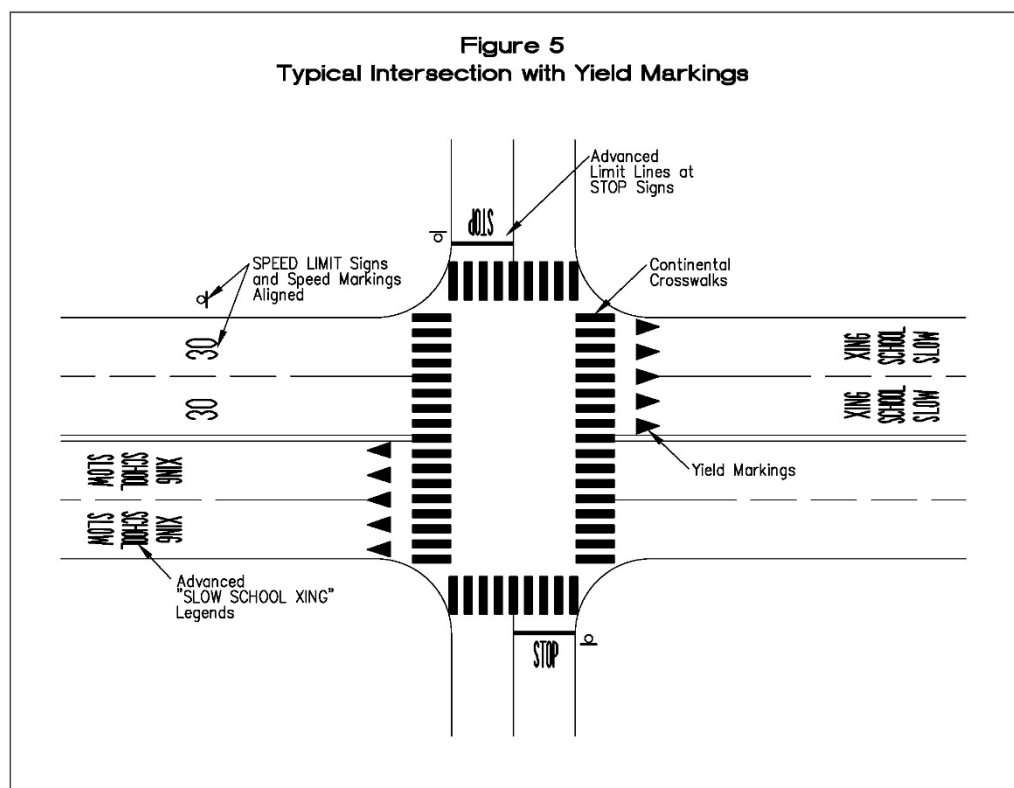
Optional rows of white triangles (i.e. "shark teeth") placed across approach lanes to indicate the point at which vehicles must yield to pedestrians (**Figure 5**). This type of marking is proposed at the crosswalks adjacent to Newport Elementary School and at "E" Street as an additional pavement message.

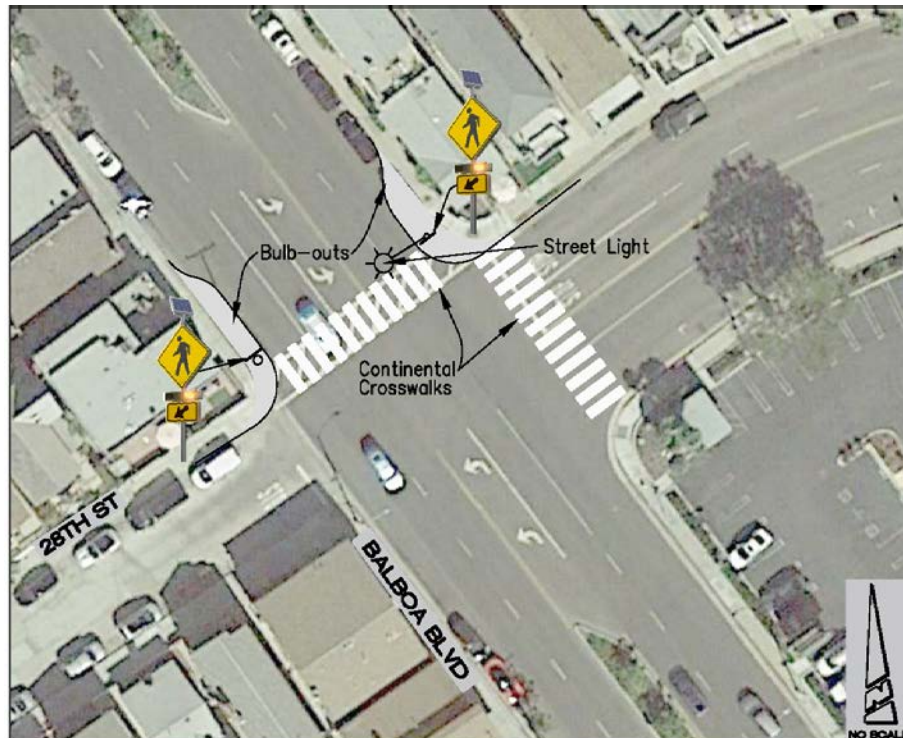
**Figure 8**  
**Recommendations at Balboa Blvd and 28<sup>th</sup> St**

This recommendation is based on the relatively high number of motorist right-of-way violations in the summer (296 or 11.8% of the total crossings). It is anticipated that the RRFB installation on Balboa Boulevard (northwest of the McFadden area) will not impact traffic flow on or off the peninsula.

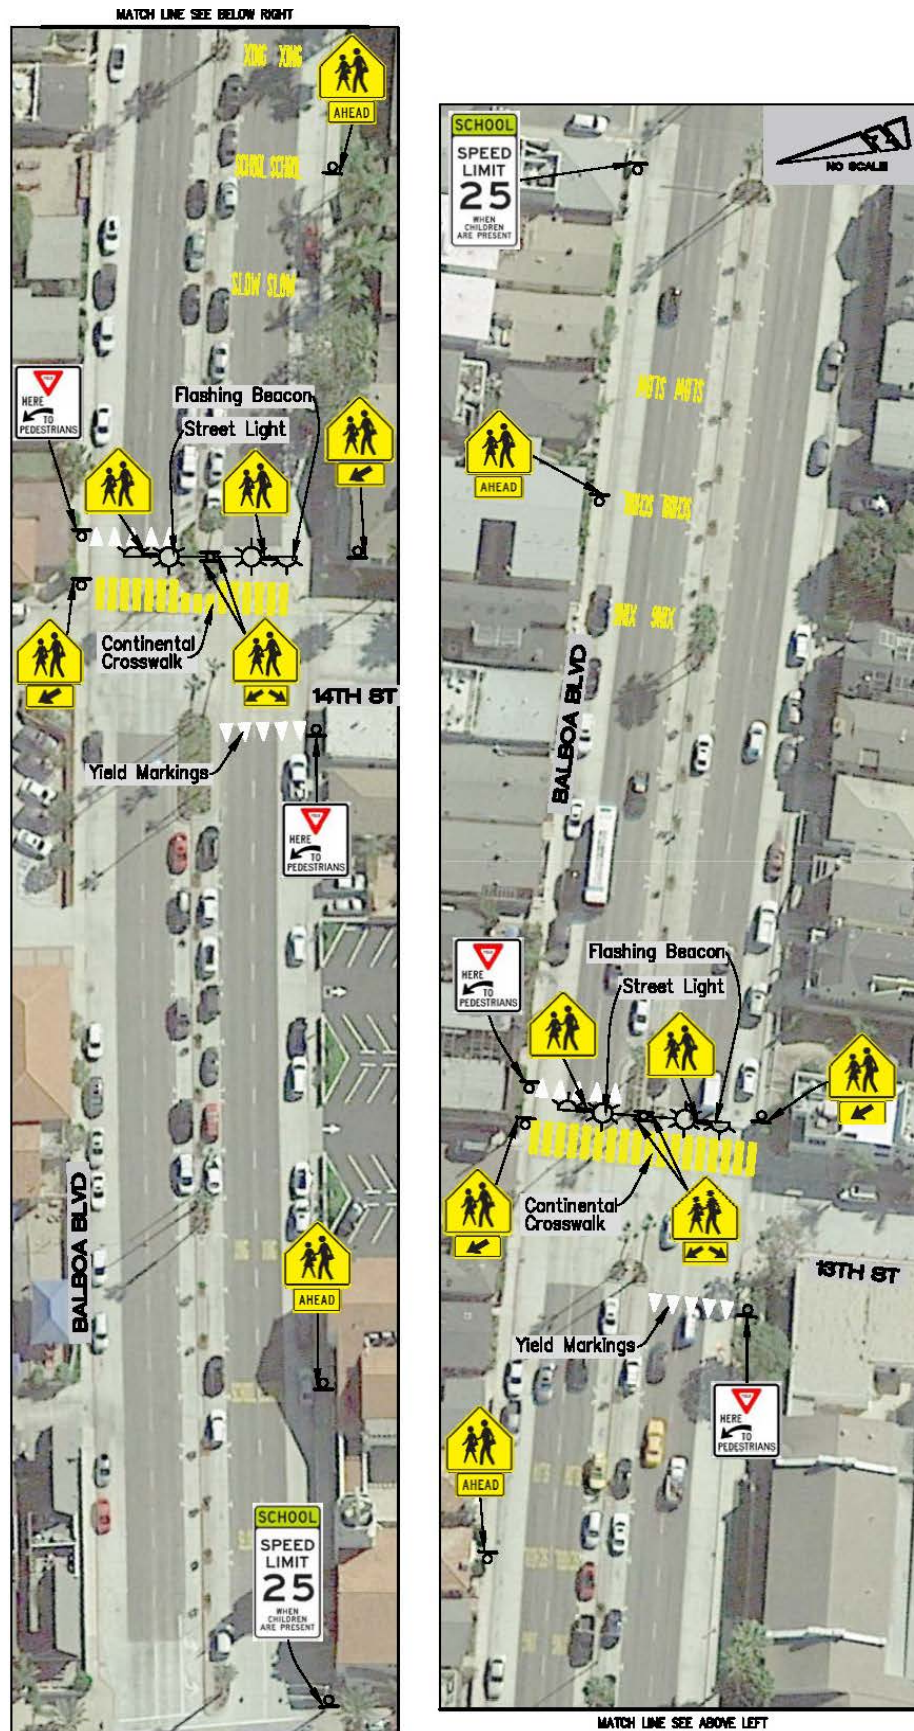
Figure 10  
Recommendations for Balboa Blvd at 13<sup>th</sup> St and 14<sup>th</sup> St

Project: Install new "School Xing" for northbound/southbound with School Crossing Ahead signs. Install "25 mph When Children Are Present". Install new street light and double mast-arm pole in median. Install an overhead School Crossing sign with flashing beacons. Install School Crossing and downward arrow signs on curb sides of crosswalk and in the median for both northbound and southbound. Install "shark teeth" advance markings and "Yield Here to Pedestrians" signs (**Figure 10** on page 22).

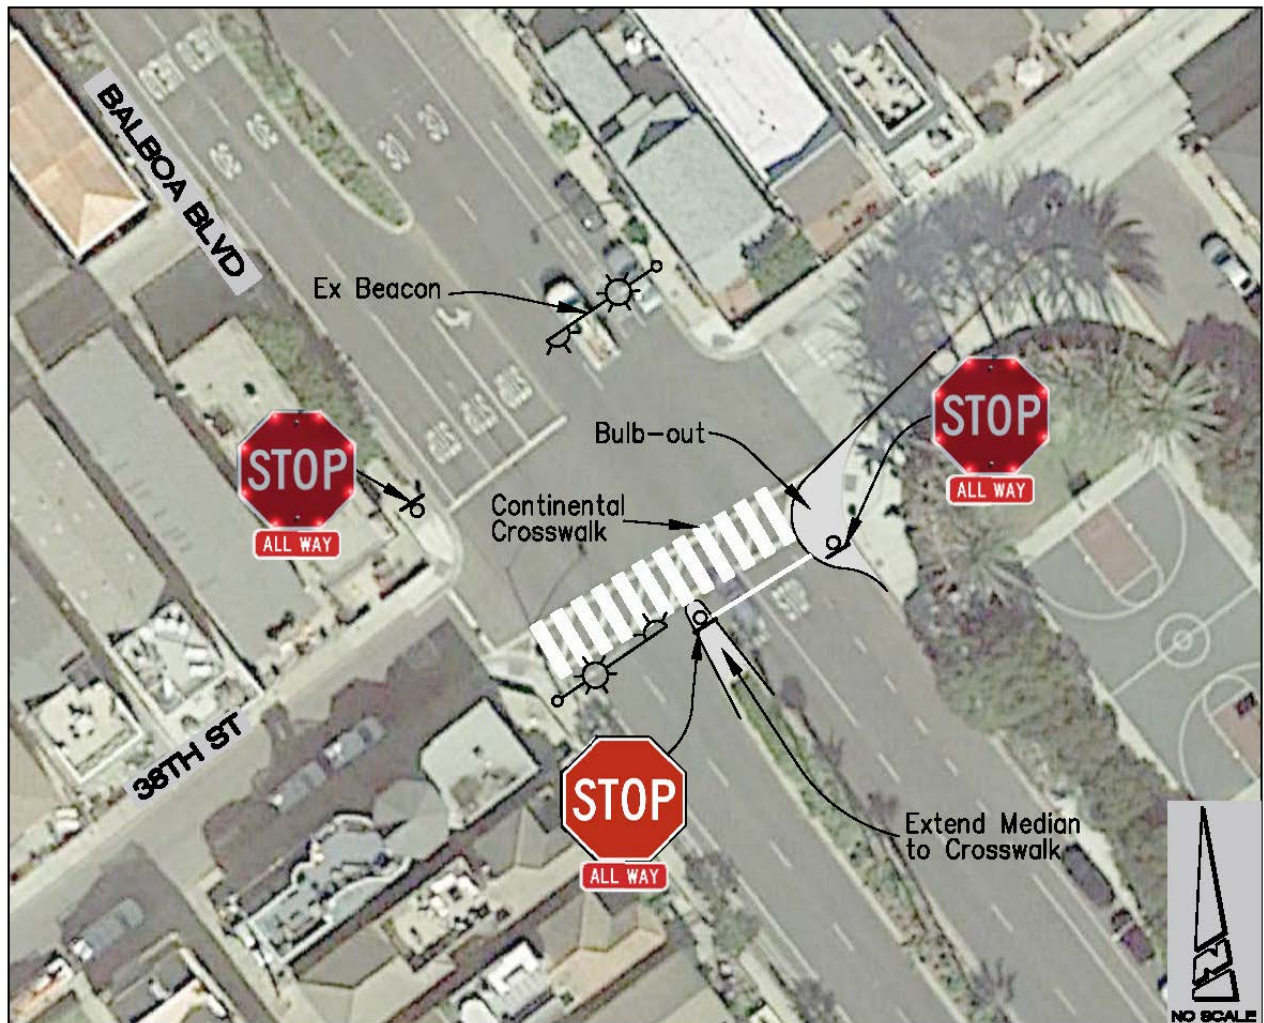
**Figure 11**  
**Recommendations at Balboa Blvd and 38<sup>th</sup> St**

Project: Install LED edge lit "STOP" signs at the limit line for northbound and southbound vehicles (LED edge lit "STOP" signs installed 7/26/2017). Install a bulb-out on the southeast corner. Extend the median on the south leg up to the crosswalk and provide an additional "STOP" sign in the median (**Figure 11** on page 25).
